# Expert Report

**Wadsworth v. Jetson et al**

Derek King, M.S., P.E.

Berkeley Engineering and Research, Inc.  
July 12, 2024

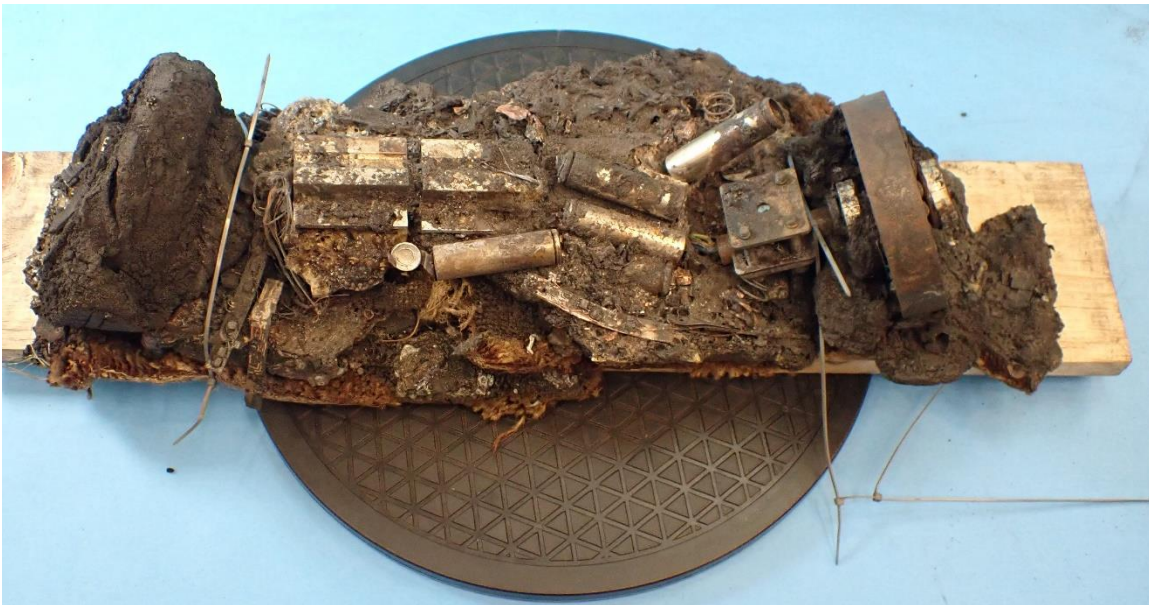
*Figure 1: The remnants of the subject Jetson hoverboard.*

Detailed examination of the subject board shows that two out of ten cells exploded while the other eight cells show heat damage. Exploding cells are consistent with an internal short, thermal runaway, and vaporization and ignition of the liquid electrolyte.

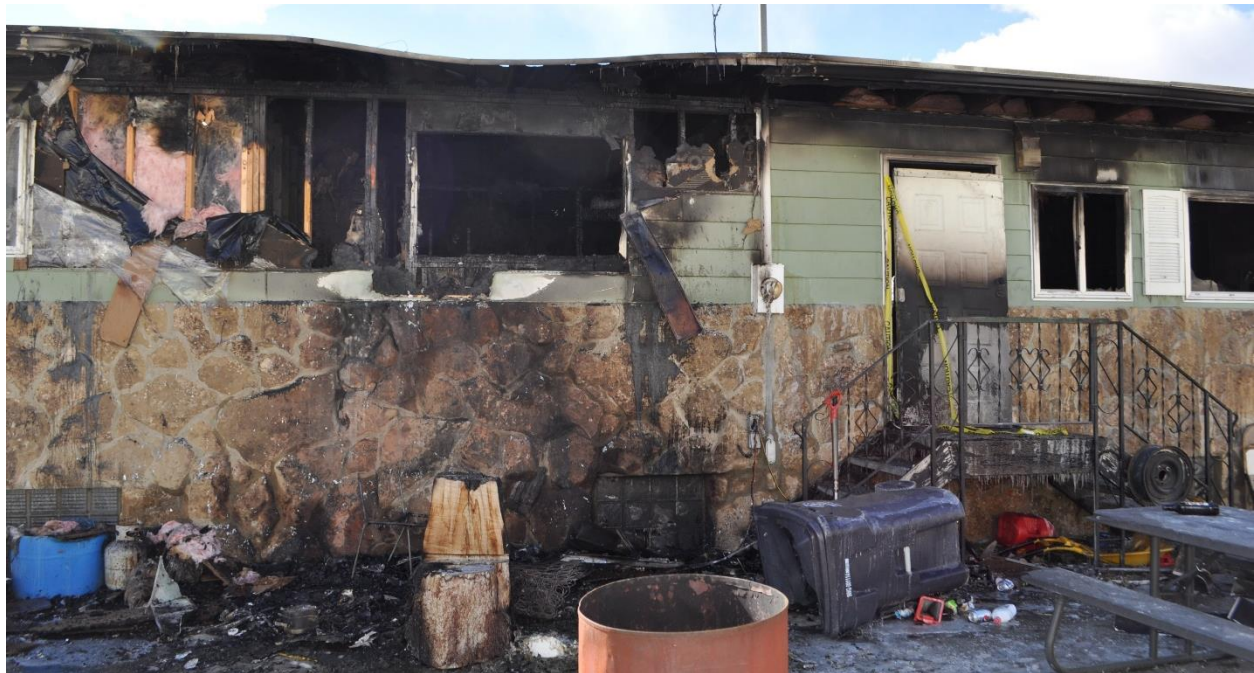
*Figure 2: The bedroom window where the subject hoverboard was found.*

- An exterior fire would have to rise along the wall, enter through the eaves, and then burn down to eventually reach the subject board. The exterior wall should therefore be exposed to the fire for the longest duration.
- The exterior of the house at and around the window area is substantially less fire damaged than the interior. The exterior wall studs are largely intact. This suggests a shorter and less intense exposure to fire on the outer wall compared to the interior.
- Detective Sheaman observed an interior V-pattern which included studs which were nearly completely consumed by the fire.

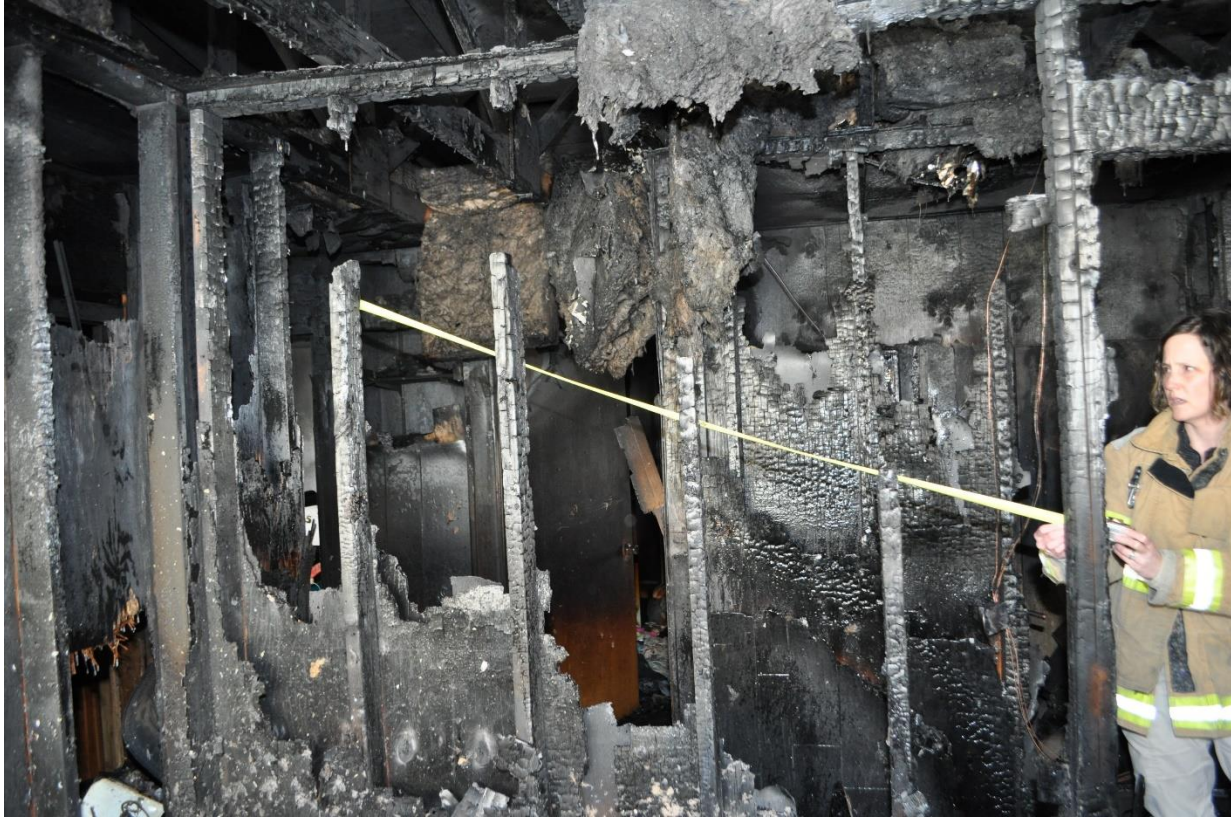
*Figure 3: Interior wood studs in the bedroom/hallway wall show preferential consumption from fire pointing towards the subject board location (“V-pattern”).*

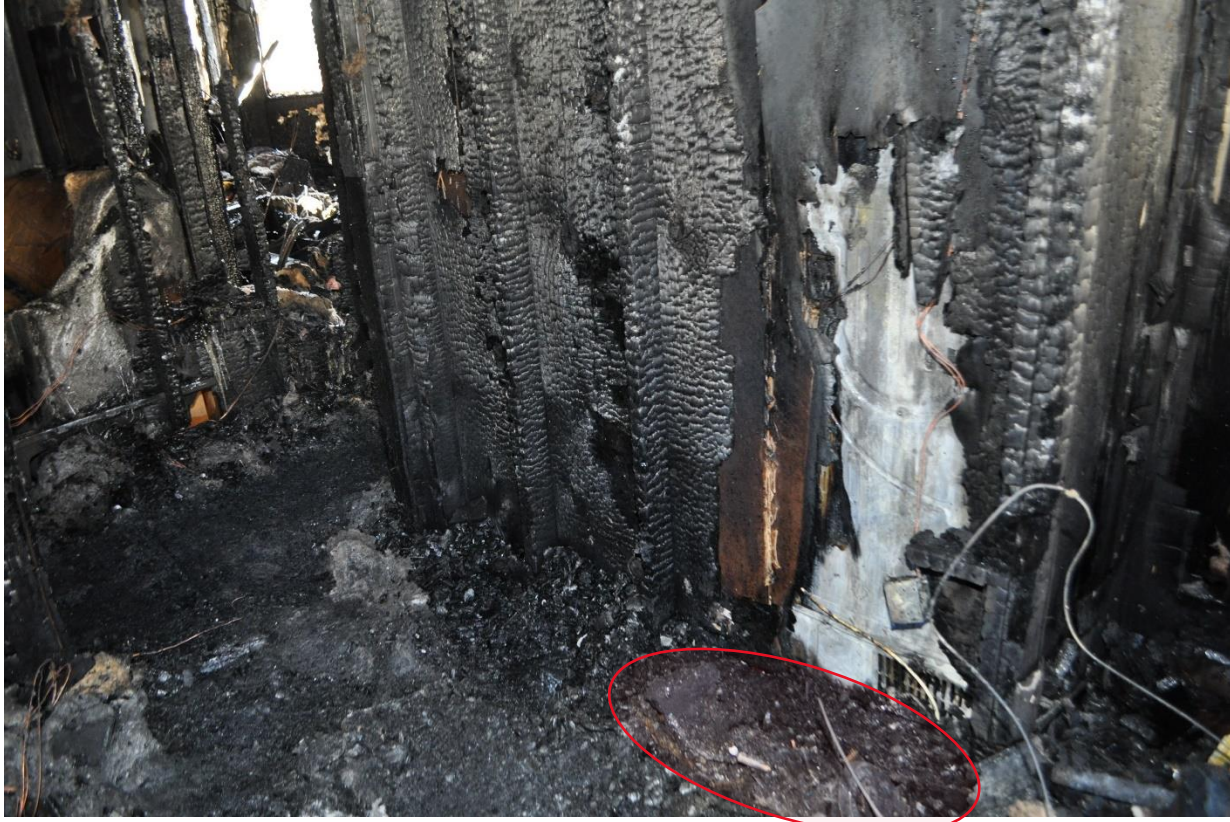
*Figure 4: The general location of where the wall V-pattern points. The wall above the subject board (circled) is completely burned away.*

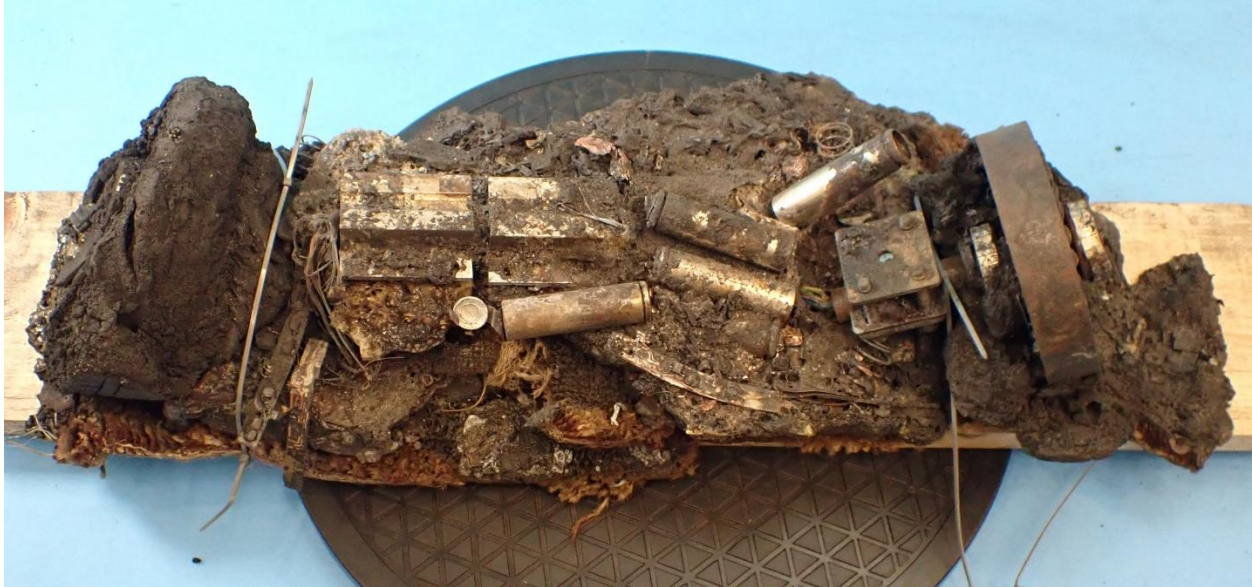
*Figure 5: The subject board as-received by BEAR. The wood plank appears to be added for physical support of the loose evidence.*

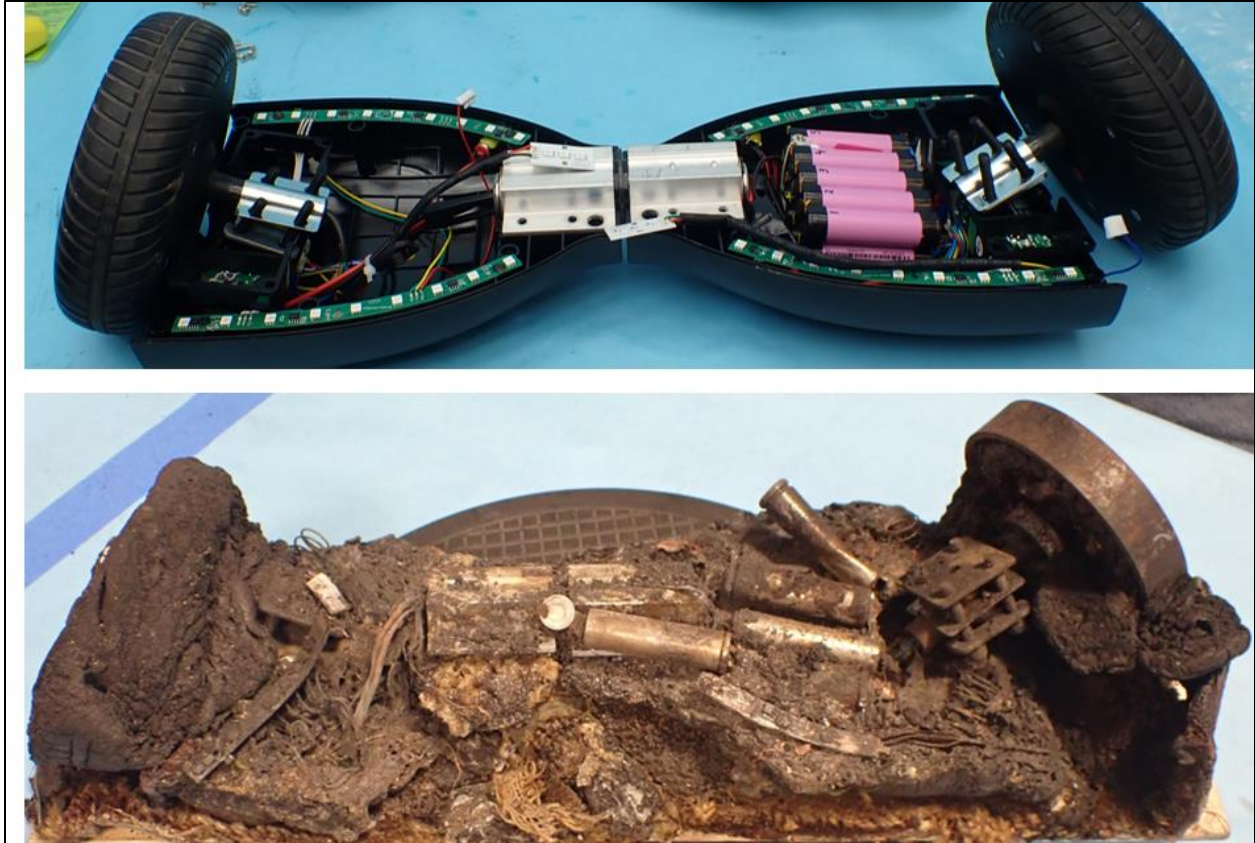
Figure 6: An exemplar board disassembled and oriented approximately the same as the evidence.

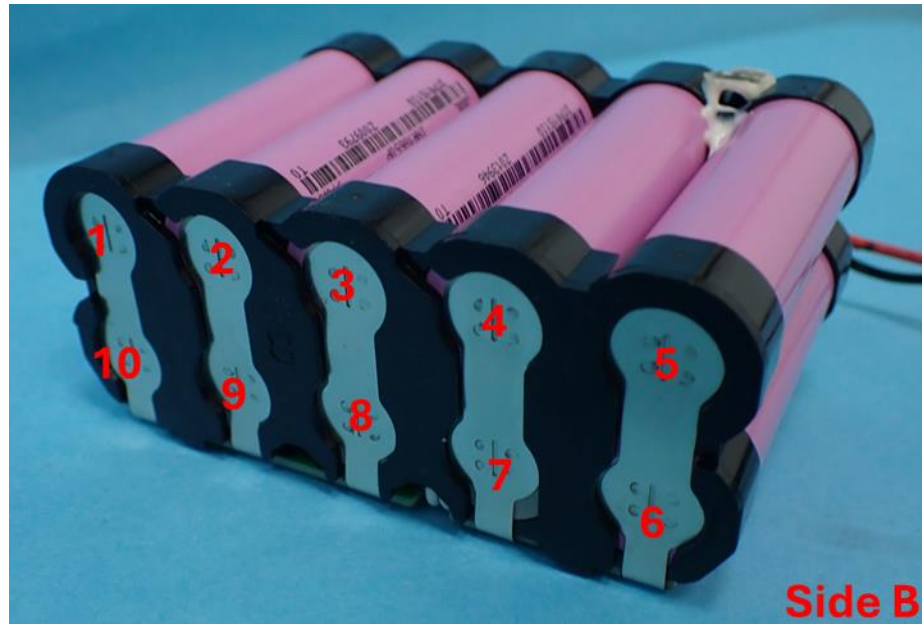
Figure 8: The other side of the exemplar battery pack with cells numbered for positional reference.
